DEPARTMENT OF TRANSPORTATION

Quality Assurance and Source Inspection

Contract #: 04-0120F4Cty: SF/ALA Rte: 80 PM: 13.2/13.9File #: 69.28**WELDING INSPECTION REPORT****Resident Engineer:**Siegenthaler, Peter**Address:** 333 Burma Road**City:** Oakland, CA 94607**Report No:** WIR-018418**Date Inspected:** 17-Oct-2010**Project Name:** SAS Superstructure**OSM Arrival Time:** 645**Prime Contractor:** American Bridge/Fluor Enterprises, a JV**OSM Departure Time:** 1845**Contractor:** Zhenhua Port Machinery Company, Ltd (ZPMC), Changxing Island **Location:** Shanghai, China**CWI Name:** Wang Zhu.**CWI Present:** Yes No**Inspected CWI report:** Yes No N/A**Rod Oven in Use:** Yes No N/A**Electrode to specification:** Yes No N/A**Weld Procedures Followed:** Yes No N/A**Qualified Welders:** Yes No N/A**Verified Joint Fit-up:** Yes No N/A**Approved Drawings:** Yes No N/A**Approved WPS:** Yes No N/A**Delayed / Cancelled:** Yes No N/A**Bridge No:** 34-0006**Component:** Orthotropic Box Girder(OBG)**Summary of Items Observed:**

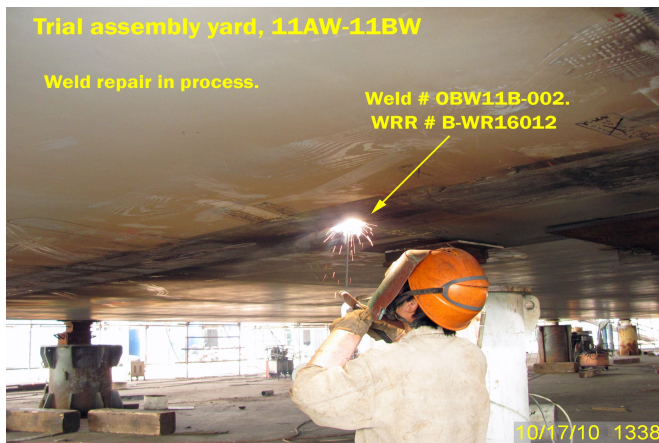
SMAW Repair welding of weld joint OBW11B-002 (WRR # B-WR16012); located at Trial assembly yard. Welder is identified as 040656; ZPMC Quality Control Inspector (QC) is identified as An Qing Xiang. The welding variables recorded by Quality Control Inspector (QC) appeared to comply with the Applicable WPS: WPS-345-SMAW-4G(4F)-FCM-REPAIR-1. The attached photograph provides additional detail.
